Instructions for identifying the affected UNILIFT AP50B

Instructions for identifying the affected MULTILIFT MSS

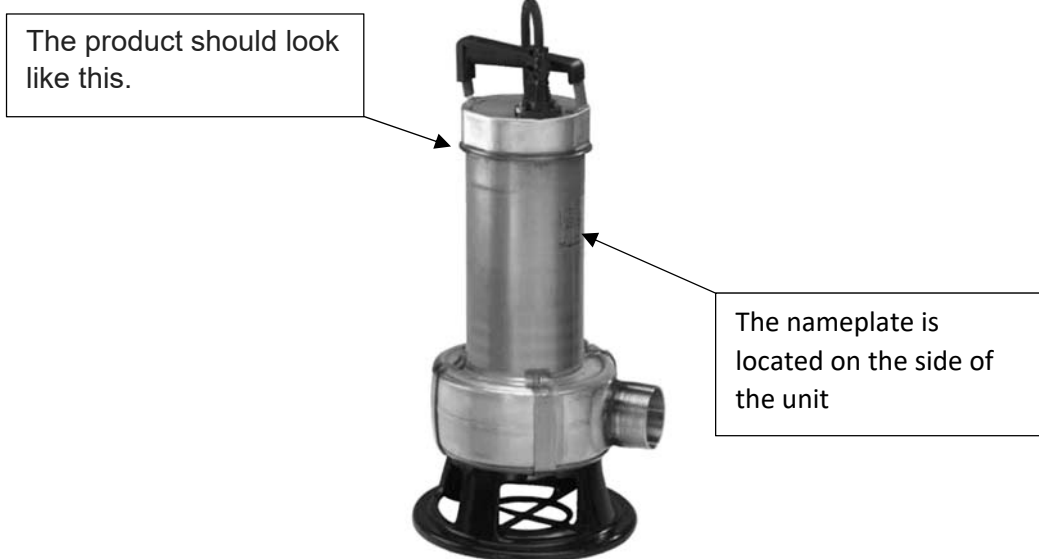
1. Verify that the pump looks like the one on the image:

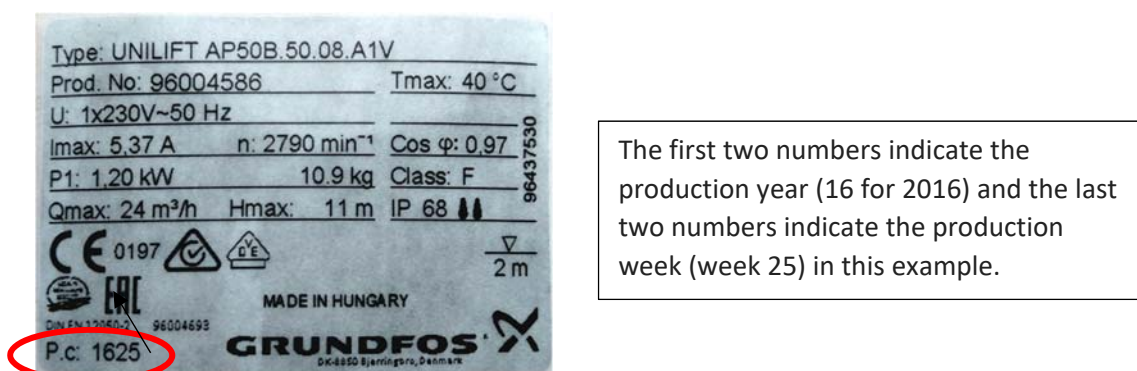
2. Check the nameplate:

3. The product needs to be replaced if the date indicates 1649 to 1735 (from week 49 in 2016 to week 35 in 2017).

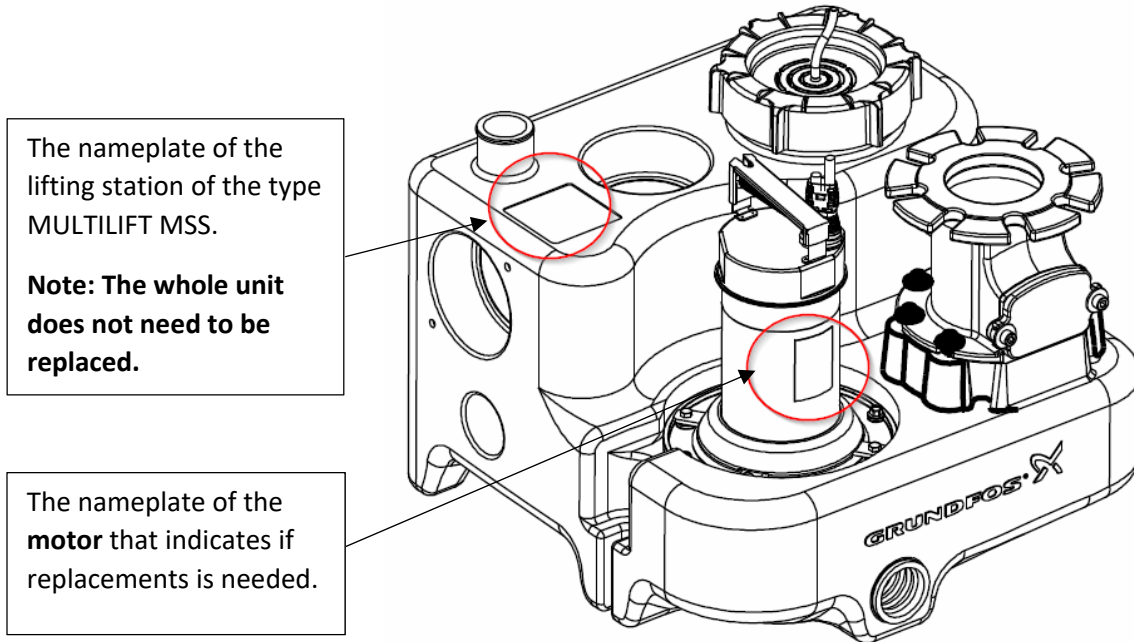
1. Verify that MULTILIFT MSS looks like the one on the image:

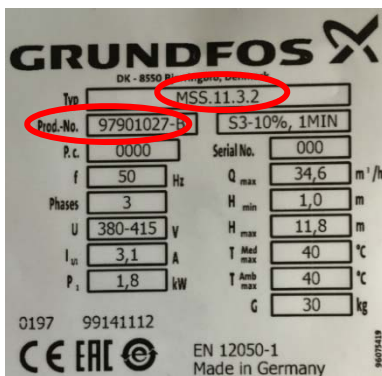
2. Check the nameplate of the **lifting station unit**:
Check the nameplate of the MULTILIFT. MSS.11.3.2 indicates potentially affected product series.
Check if the product number matches the listed numbers.

Product No:

97901027
97901029
98714824 (only China)
97901061
97901063
98721203

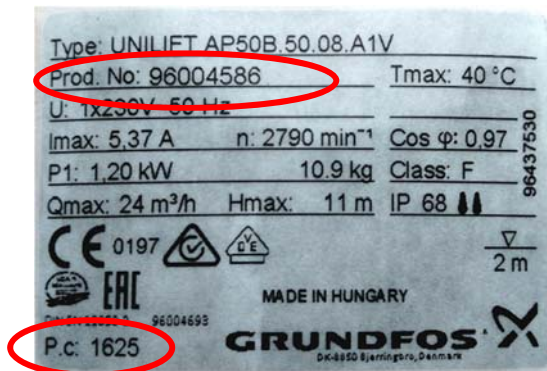
Check the nameplate of **the motor**:

Look for the product number and production codes (circled in red)..

The circled code in the bottom of the nameplate indicates the time of production (year/week). 16 for 2016, 25 for week 25.

Product No. of the motors that need to be replaced:

97823655

98094196

98167954

98167955

The motor must be replaced if the code is between 1227 to 1735 (from week 27 in 2012 to week 35 in 2017).
